Field Evaluation of Ozone for Control of Corrosion and  
Scale in a Zero Blowdown Application

Association of Water Technologies  
Fifth Annual Convention  
November 18 to 21, 1992

by: Timothy Keister  
ProChemTech, Inc.

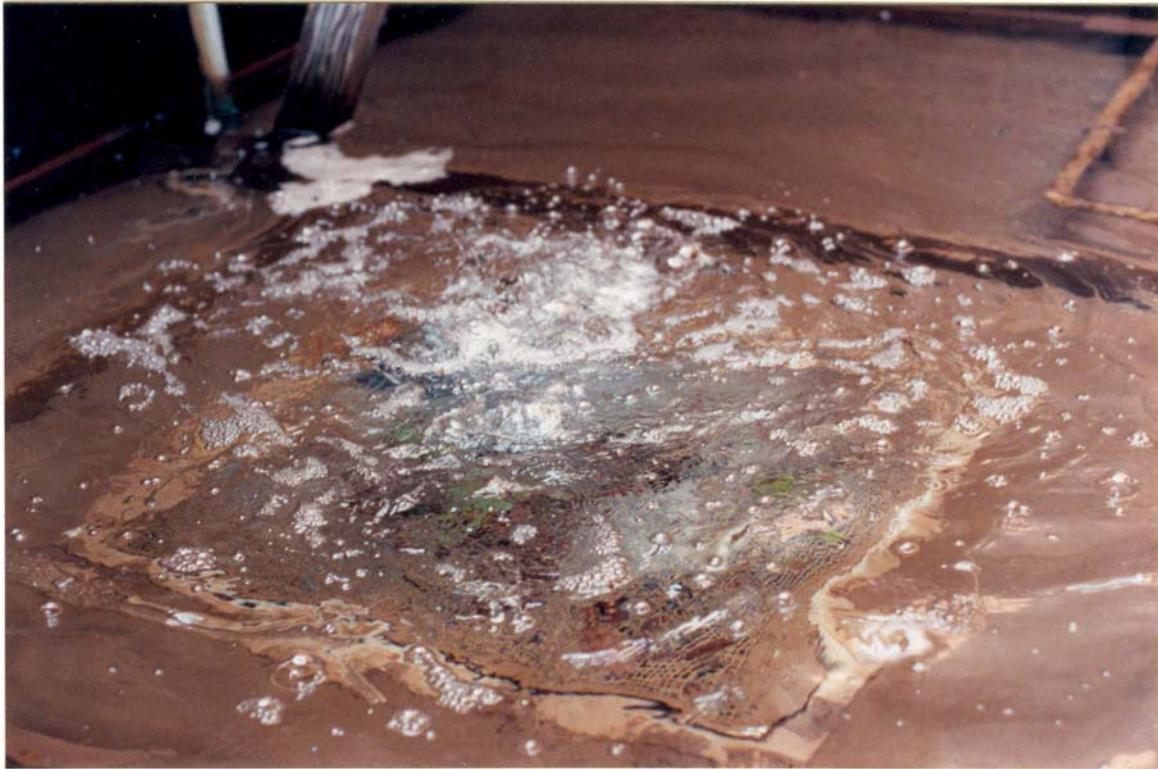
Ozonated water is piped from the ozone generator and discharged directly into the cooling tower basin as shown. A definite ozone odor was present around the cooling tower at all outputs exceeding one lb/day, with plant personnel reporting that the ozone being released into the air during higher outputs was intolerable near the cooling tower.

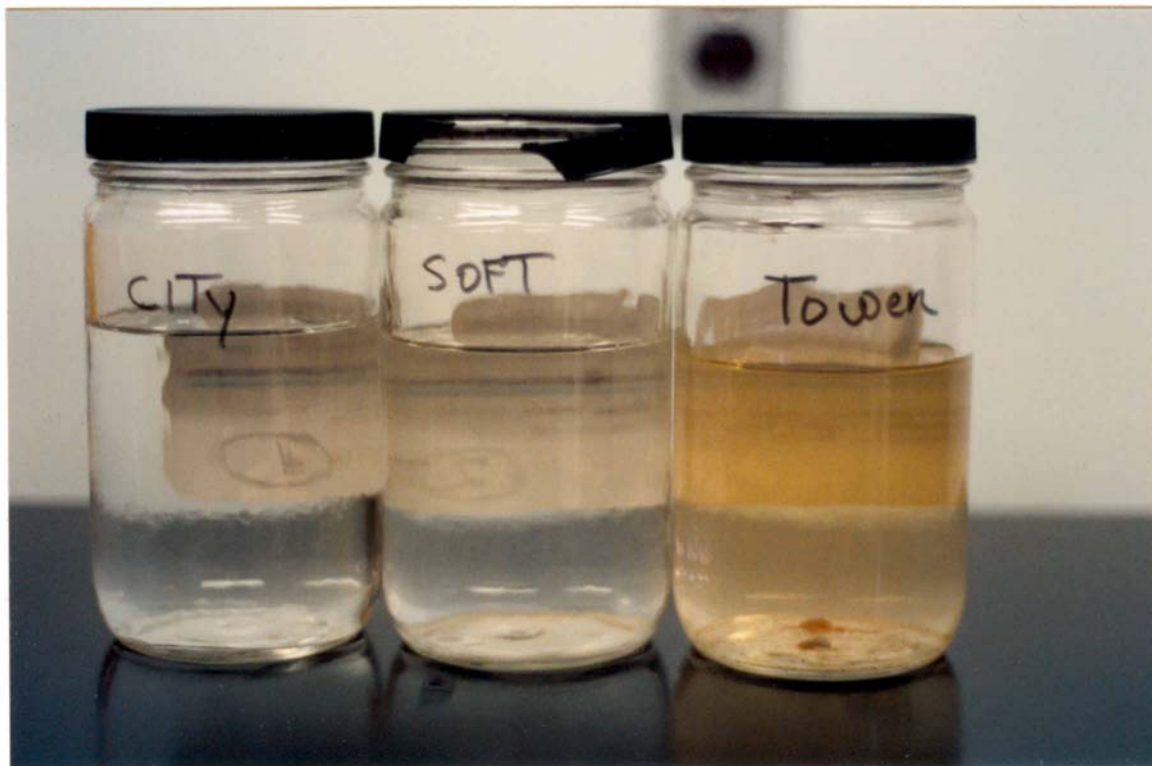
As shown in the preceding photo, the cooling water sample was reddish in color with some red floc present, likely due to the substantial amount of iron in the water. The analysis data clearly indicates that substantial corrosion was taking place within the cooling system prior to the sampling.

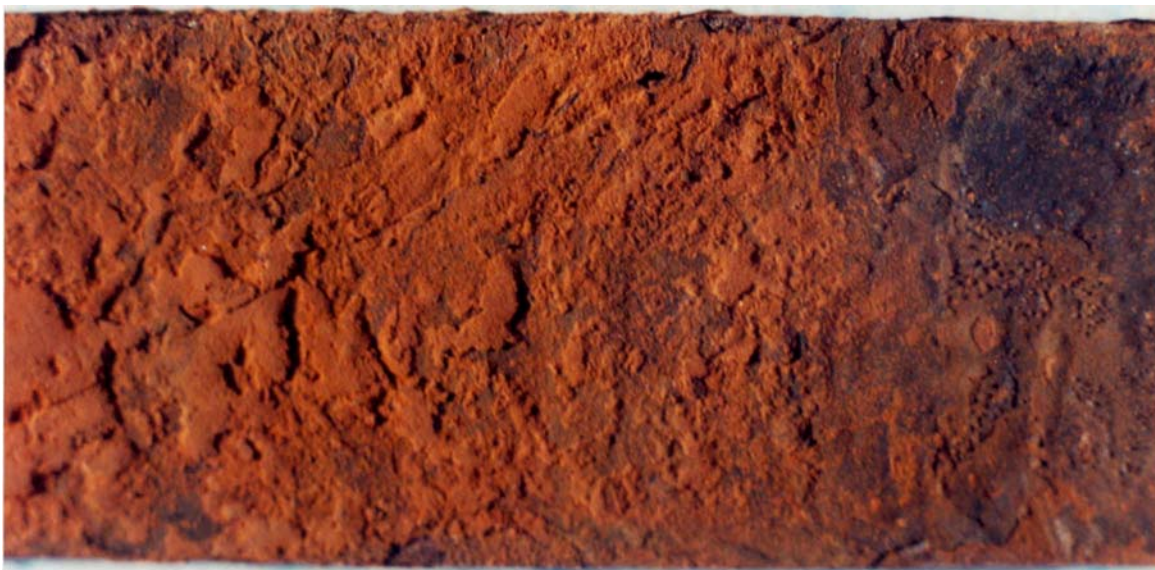
The conclusion reached from the water analysis results that the ozone treated system was corroding at an excessive rate is confirmed by the above corrosion coupon results. As a basis for comparison, chemically treated cooling systems using softened makeup water and operated at high cycles typically obtain corrosion rates below 1 mil/yr on identical 1010 mild steel corrosion coupons.

As shown by the following closeup of a portion of one of the above steel corrosion coupons, corrosion and resultant deposition of corrosion products was substantial.

CLOSE UP PHOTO OF CORROSION COUPON, OZONE/SOFT WATER

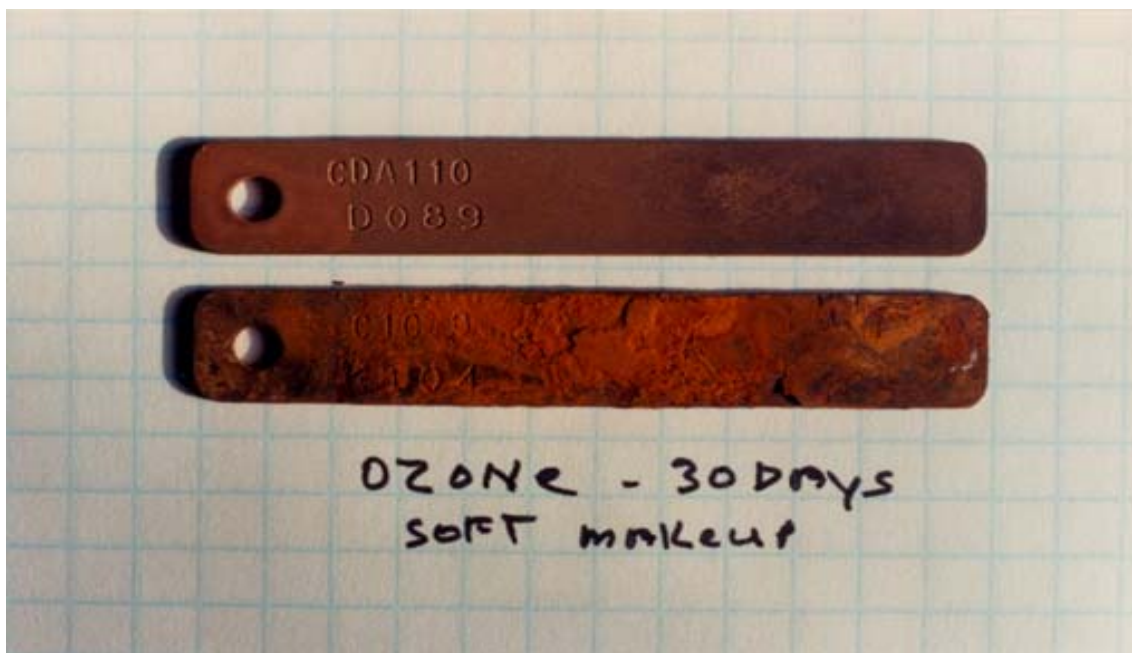
The above second set of corrosion coupons were installed on April 7, 1992, and removed 30 days later on May 6, 1992. Analysis of these corrosion coupons gave the following results.

These results confirm the previous findings that the corrosion rates in the system were excessively high.

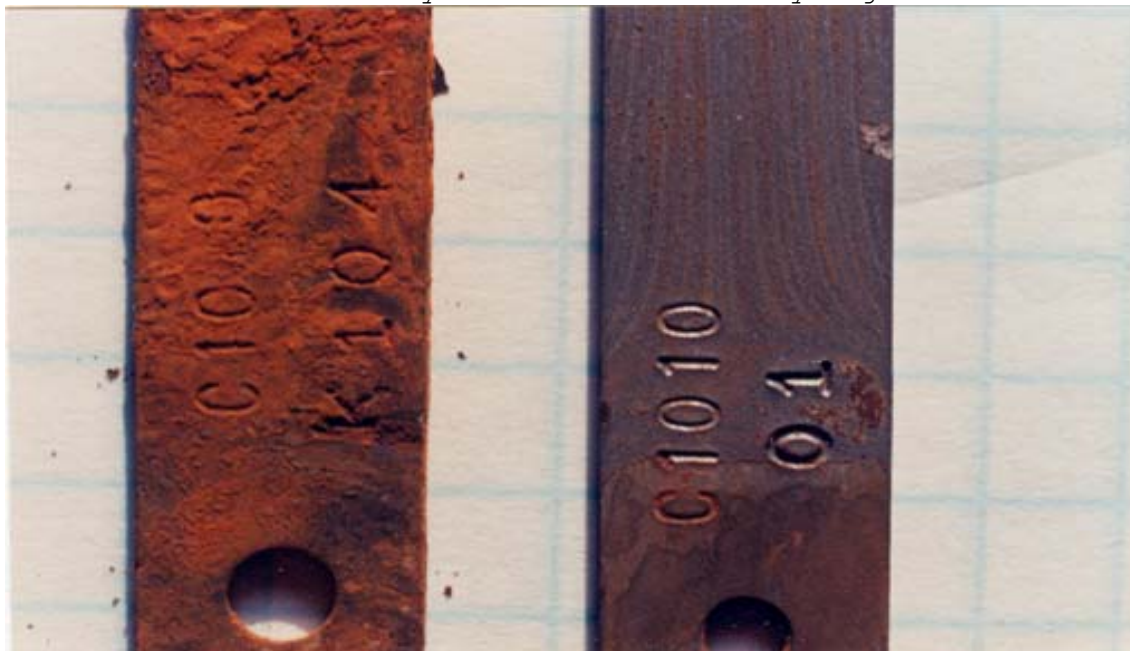
COUPONS FROM OZONE AND CHEMICALLY TREATED SYSTEMS

The previous photo compares a 1010 mild steel corrosion coupon exposed for 30 days in the ozone treated cooling system beside a similar coupon exposed for 60 days in a cooling tower system running high cycles with soft water makeup and a molybdate-silicate chemistry program. Corrosion rate on the ozone treated coupon is 20.57 mil/yr, while the chemically treated coupon showed a rate of 0.29 mil/yr.

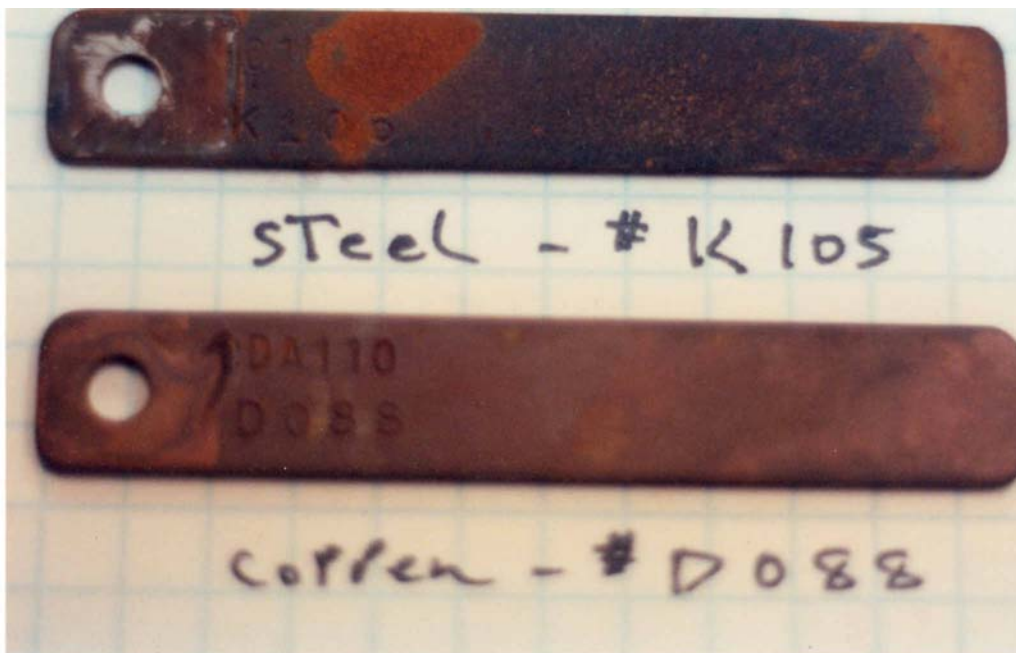
The above third set of corrosion coupons was installed on May 7, 1992, and removed 30 days later on June 7, 1992. Analysis of these corrosion coupons gave the following results.

As expected, these results show a substantial decrease in corrosion rate due to use of hard water in the cooling system and resultant operation under scale forming conditions.

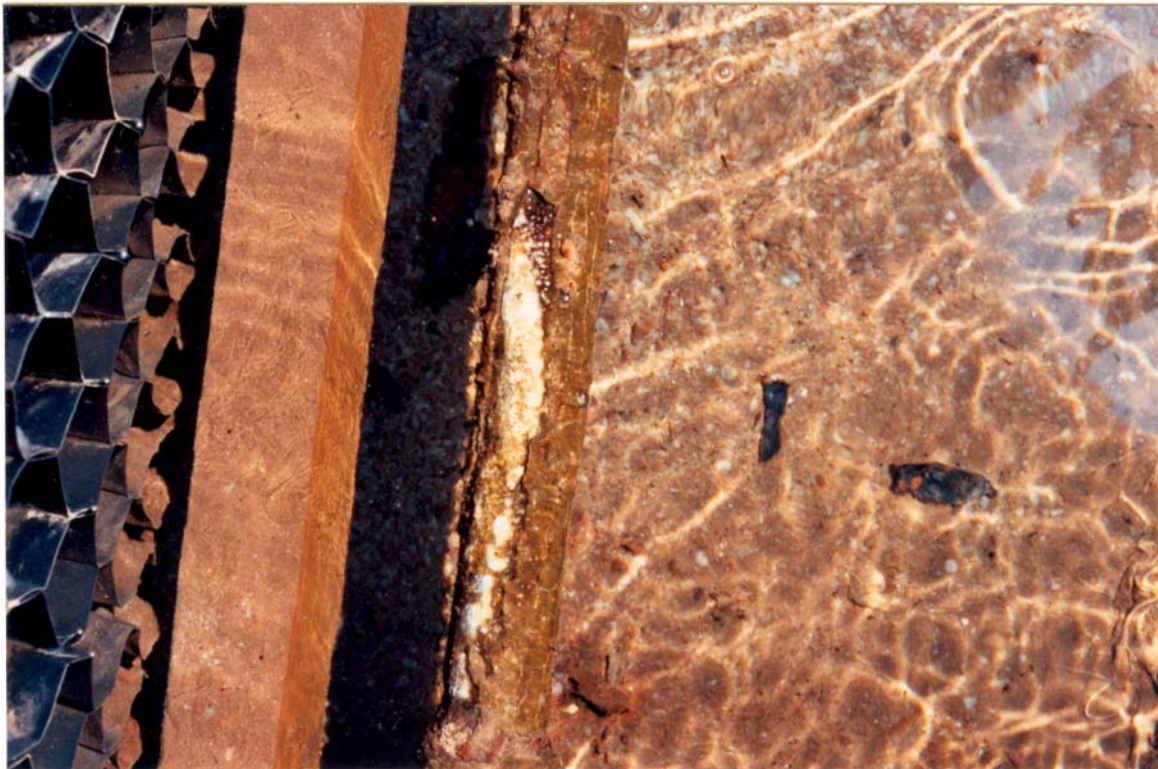
Substantial buildup of scale was noted on the heating coil in the cooling tower basin during this time period. A sample of scale was obtained on July 7, 1992, and analyzed with the following results obtained.

These scale analysis results show that calcium, magnesium, iron, and silicon are present in scale formed from the ozone treated cooling water. Based on the previous corrosion rates, the iron component is believed to result from deposition of corrosion products, while the calcium, magnesium, and silicon are supplied from the makeup water.

As shown by the following photo, the scale is a hard material which adheres to the surface on which it forms. The evident spalling is believed to be due from thermal stress resultant from loss of heat transfer. Active scale formation is evident in those areas where the older scale has spalled off.

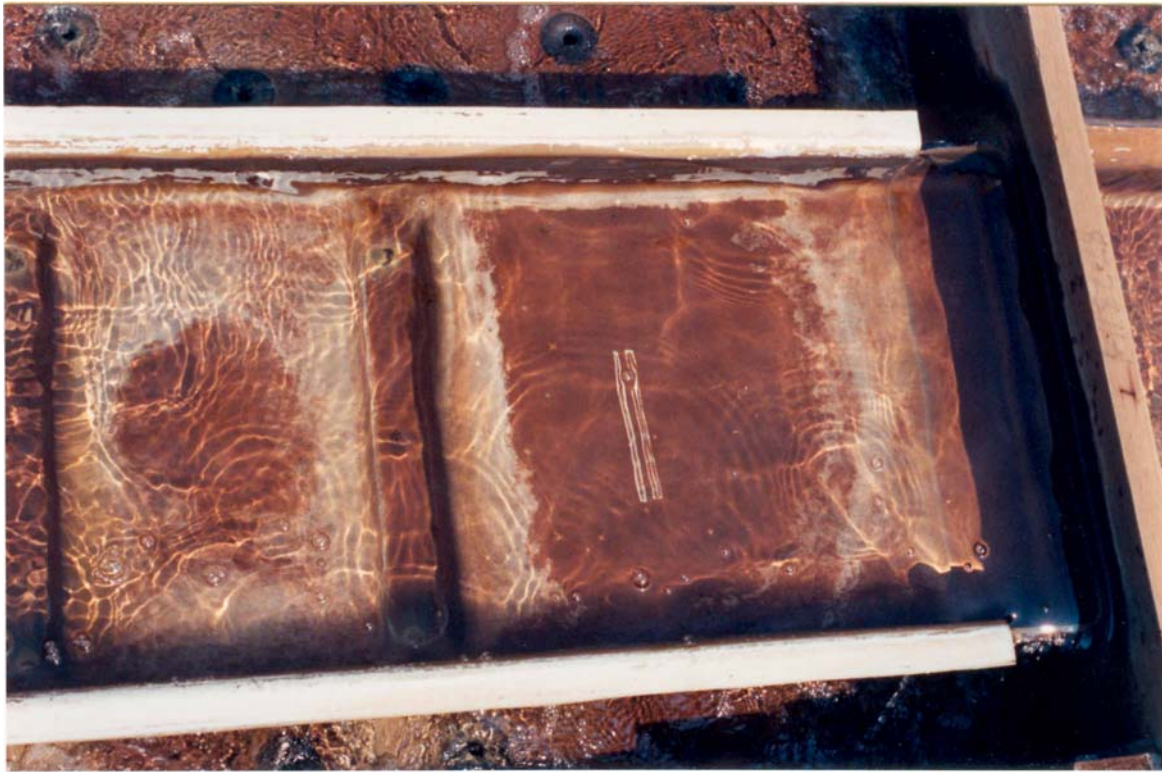
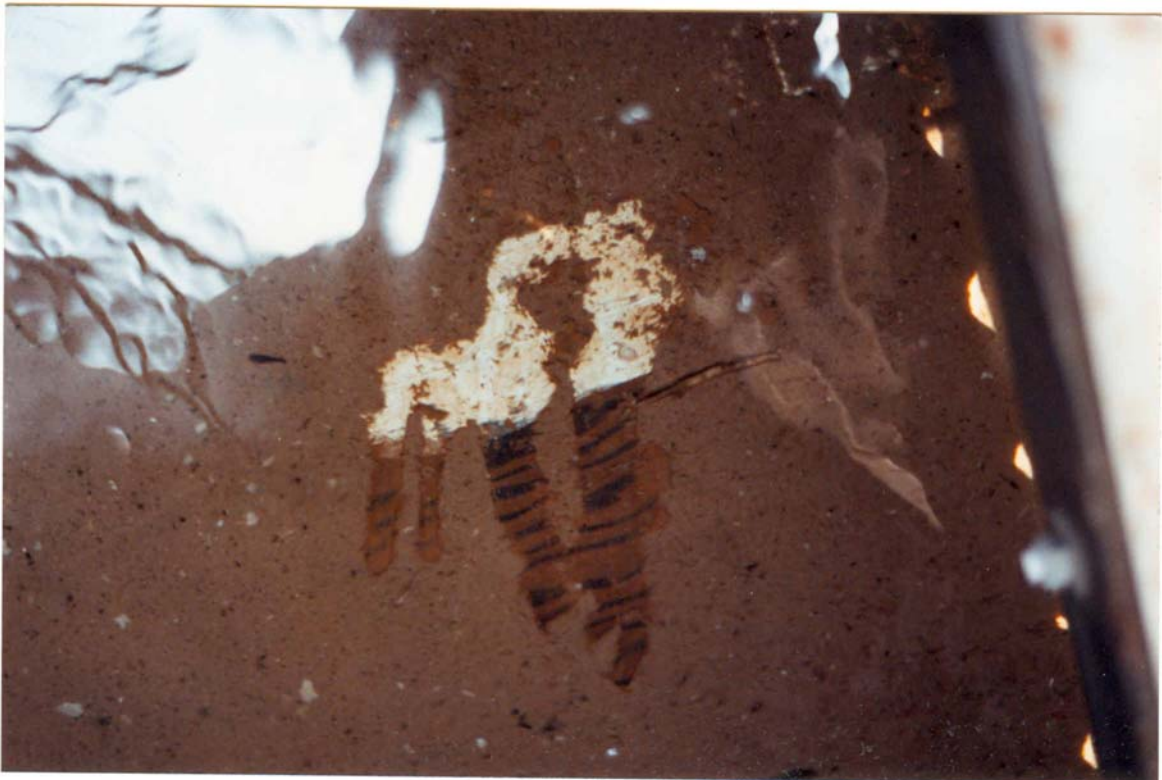
COOLING TOWER BASIN

Examination of the cooling tower distribution deck and basin on August 19, 1992, showed significant scale and deposition accumulation only on the heating coil. As shown by the two following photos, both the deck and basin were very clean. No evidence of the typical bulk precipitation and settling of hardness from the cooling water as reported in previous reviews of ozone treated zero discharge cooling towers was noted.
