## Case History Report Non-Chemical Water Treatment Device Evaluation

“VRTX Chemical Free Cooling Water Treatment System” supplied by VRTX Technologies, 5850 Corridor Parkway, Schertz, Texas, 78154, ph: 800-722-0476, FAX 210-651-7538 WEB [www.vrtx.com](http://www.vrtx.com). This evaluation is the result of a discussion between the reviewer and a principal of VRTX at the 2007 Association of Water Technologists Convention. This discussion resulted in an invitation to evaluate a VRTX installation with hard water makeup located in Tollison, AZ. The evaluation was carried out on January 16, 2008, with Mr. Leon Shapiro, VRTX Regional Manager, representing the manufacturer.

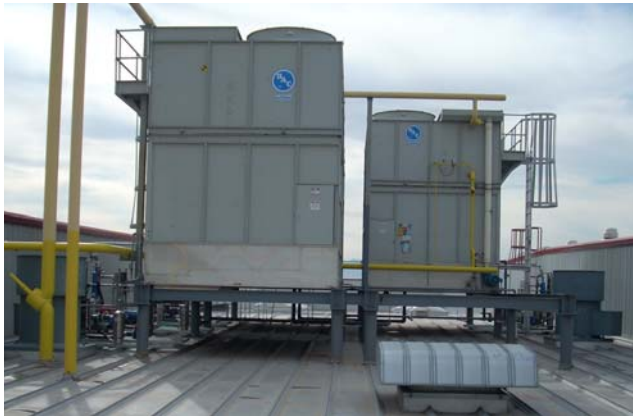
The system being treated consists of three (3) BAC Model CVX 398 ammonia condenser cooling towers with separate sumps. According to the operator, the cooling towers were installed about 2001 with an acid based chemical water treatment program used. Due to

severe corrosion damage, two of the units, CT #2 and 3 (shown to left), were replaced in 2006, with the third unit (CT #1) scheduled for replacement in early 2008. CT #1 was not operating during the evaluation. CT #2 and #3 were supplied with the BaltiBond anti-corrosion coating and stainless steel basins, while CT #1 was a standard galvanized unit. All three units are used for cooling of a refrigerated products warehouse.

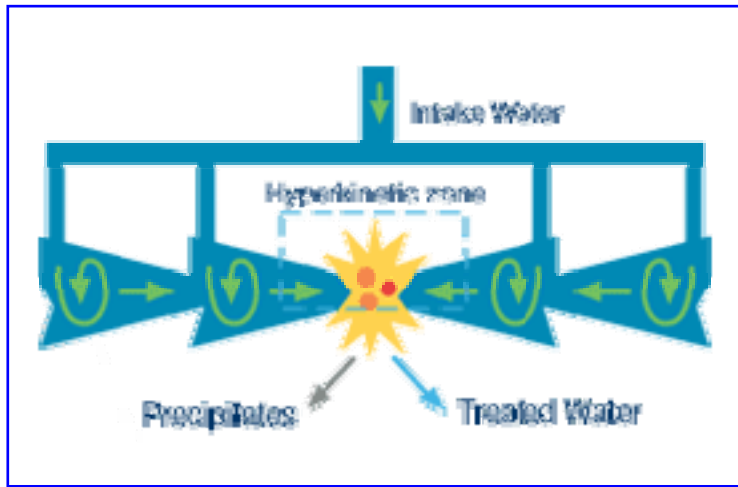
VRTX Operation Schematic

Corrosion is claimed to be controlled by “a region of near perfect vacuum forms which strips dissolved CO<sub>2</sub> from the water and typically maintains pH of the water near or above 8.5.” Apparently, pH control functions as the sole means of corrosion control.

Bacteria are controlled by “-tremendous localized temperatures and extreme fluctuations in fluid pressure within the VRTX chamber causes cell walls of microorganisms to rupture.” From this description, only planktonic organisms passing through the unit would be controlled, sessile organisms would be totally uncontrolled. No USEPA registration number was found on the WEB site for use of the VRTX as a pesticide device.

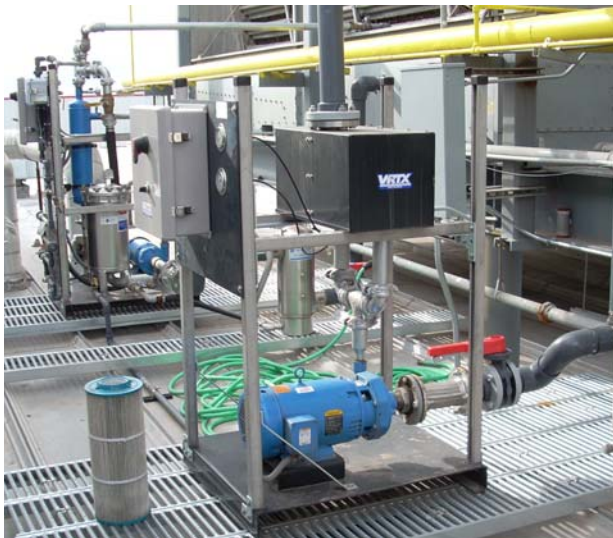
A VRTX system consisting of one 10 hp VRTX Cavitation Chamber unit and three separate skidded 10 hp hydrocyclone and cartridge filter units were installed and started up in August, 2007. The Cavitation Chamber, shown to the front in the picture, was piped to draw and discharge to all three cooling tower basins, while each filter unit, one in the background of the picture, serviced only one basin each. Other than supplemental use of 35% hydrogen peroxide for occasional algae control, no chemicals have been used in treatment of the three systems since that date.

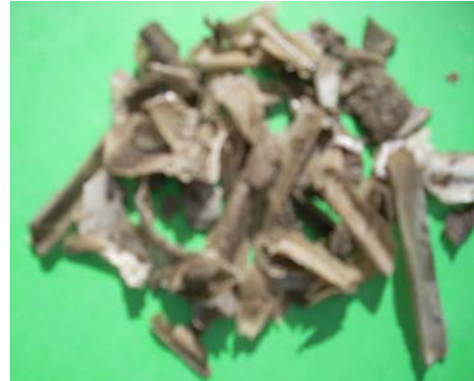
CT #1 was observed to have severe corrosion damage, believed to be due solely to misapplication of the previous acid treatment program. CT #2 was found to have a slight algae growth on the edge of the fill along with white rust of the condenser tubes and small areas of hard scale in low flow areas on the hottest tubes. CT #3 had substantial scale in the cooling tower fill with slight white rust on the condenser tubes. **A photograph, taken on-site, of scale removed by the reviewer from CT #3 fill is to the right.**

### Scale removed from CT 3 fill

Parameter	Fill scale
loss on ignition - %	37.4
aluminum - % as Al <sub>2</sub> O <sub>3</sub>	0.30
calcium - % as CaO	54.6
copper - % as CuO	0.03
iron - % as Fe <sub>2</sub> O <sub>3</sub>	0.28
magnesium - % as MgO	1.16
silicon - % as SiO <sub>2</sub>	0.99
zinc - % as ZnO	0.42
total accounted for	95.18

**Scale Control:** The analytical data on the waters from both cooling towers clearly shows a substantial loss of calcium from both systems using the cycles and Ca:Mg ratio comparison methods, as well as a substantial loss of alkalinity. This analytical loss is confirmed by the small hard scale deposits observed in hot spots on the condenser tubes of CT #2 and the extensive scale found in the fill of CT #3. Analysis of the scale sample removed from CT #3 fill shows it to be a typical high calcium carbonate scale, which would be expected when operating a cooling system above the saturation index without chemical scale inhibitors.

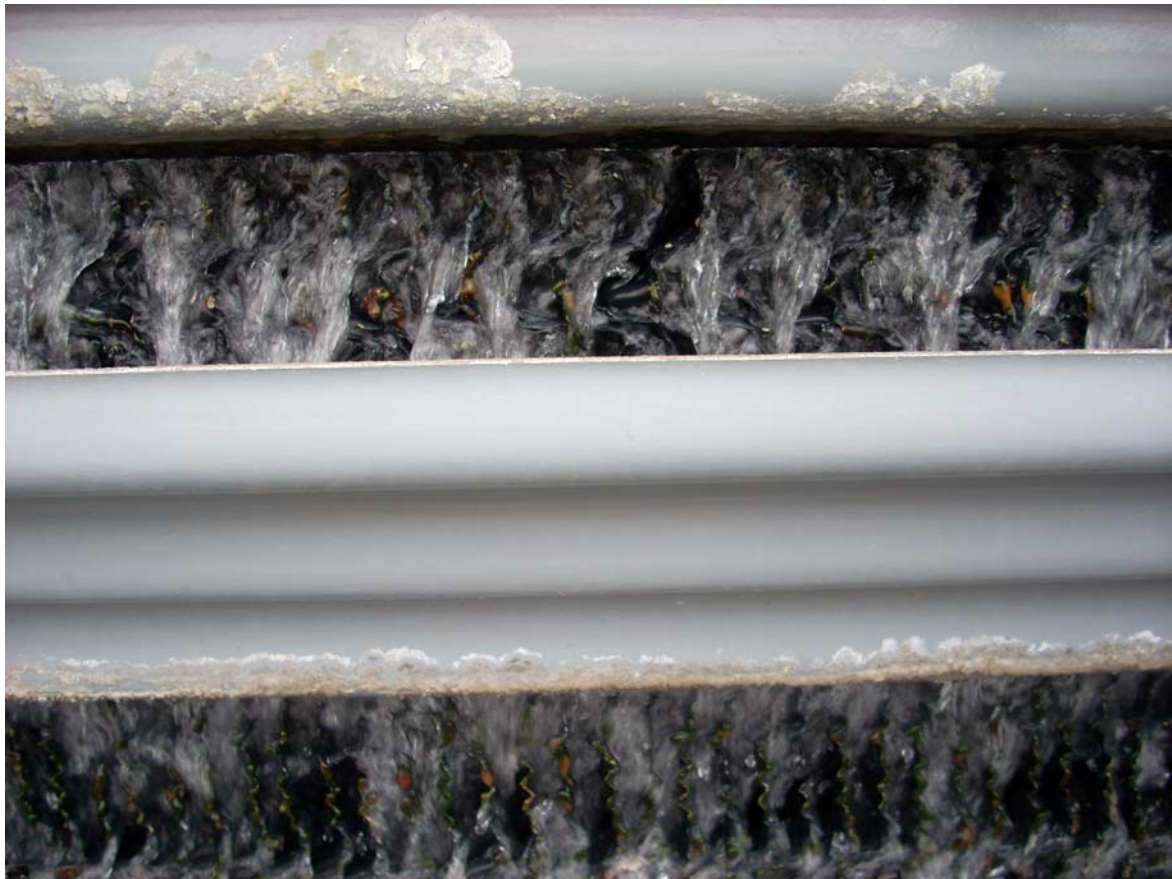
**CT #2 fill showing algae growth on the fill.**

Observation of algae growth on the cooling tower fill is a good indication that the VRTX device offers no control of algae in a cooling water environment.
