Field Evaluation of Ozone for Control of Corrosion and  
Scale in a Zero Blowdown Application

Association of Water Technologies  
Fifth Annual Convention  
November 18 to 21, 1992

by: Timothy Keister  
ProChemTech, Inc.

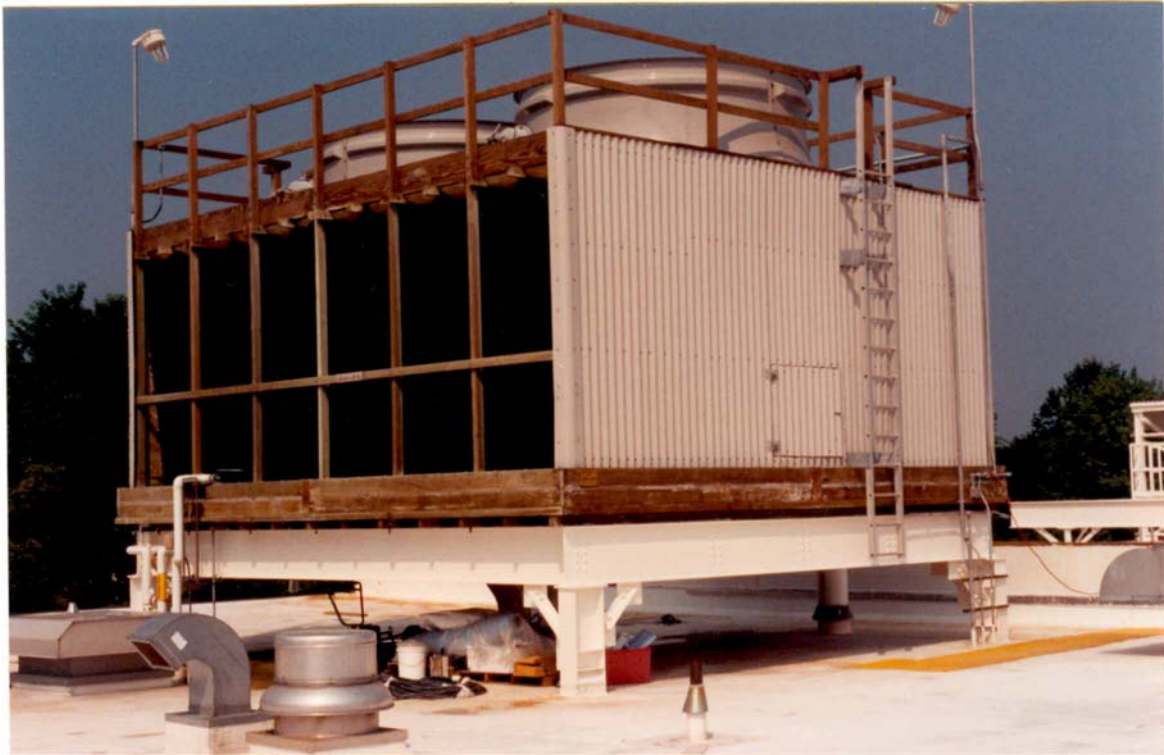
The new cooling system uses the above pictured Marley Company dual cell, induced draft crossflow cooling tower of approximately 1000 tons capacity for evaporative heat rejection. System materials of construction include treated wood, fiberglass, polyvinyl chloride, and galvanized steel in the cooling tower; black iron piping; and yellow metal alloys in the air compressor and chiller served by the system. A steam heated coil constructed of galvanized steel pipe is installed in the cooling tower basin, which serves as the system cold well, for freeze protection.

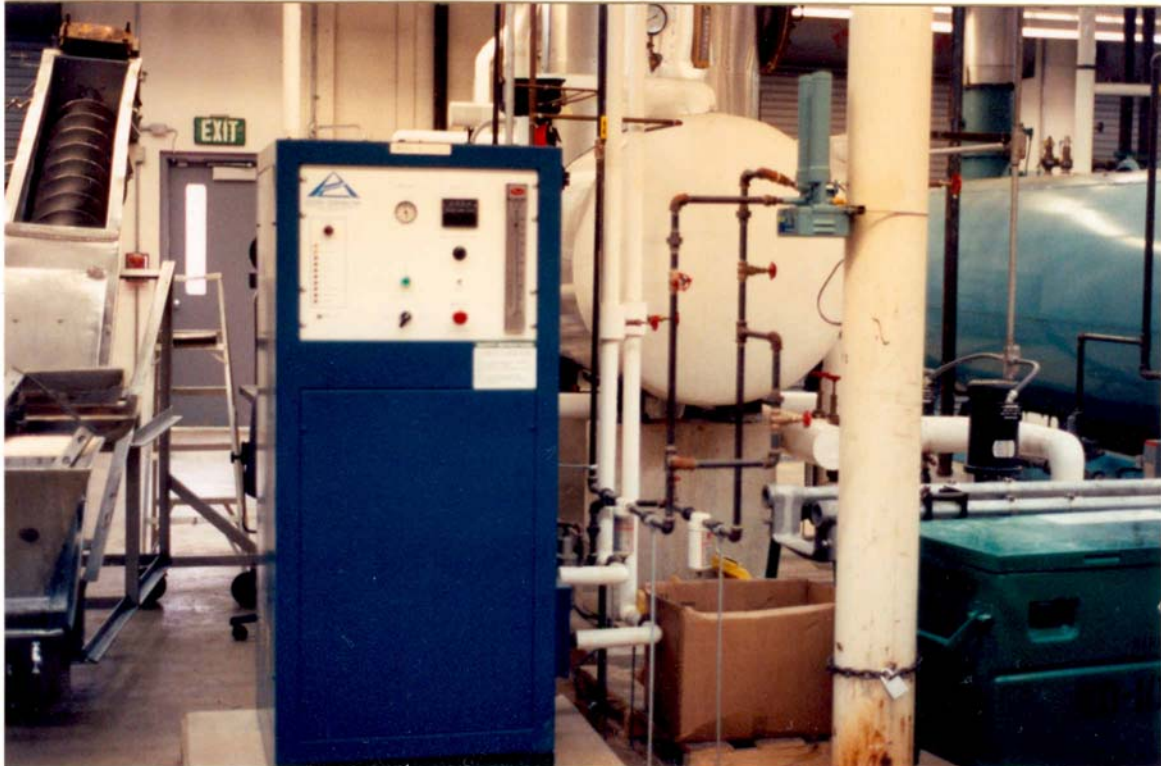
Ozone treatment of the cooling system is supplied by the pictured PCI Ozone and Control Systems Model G 7 ozonator, which is rated 0 to 7 lbs/day of ozone. The unit operates as a side stream device, generated ozone is injected into cooling water passing through the unit. Cost of this unit is reported by the manufacturer to be in the \$20,000 range. We did note that several gpm of one pass city water was being used to cool the ozonator as cooling system water was reported to be too warm for such use.

Ozonated water is piped from the ozone generator and discharged directly into the cooling tower basin as shown. A definite ozone odor was present around the cooling tower at all outputs exceeding one lb/day, with plant personnel reporting that the ozone being released into the air during higher outputs was intolerable near the cooling tower.
